THE HOUSE AT GLENMONT

HOME OF THOMAS EDISON

Historic Structure Report

THE HOUSE AT GLENMONT
HISTORIC STRUCTURE REPORT

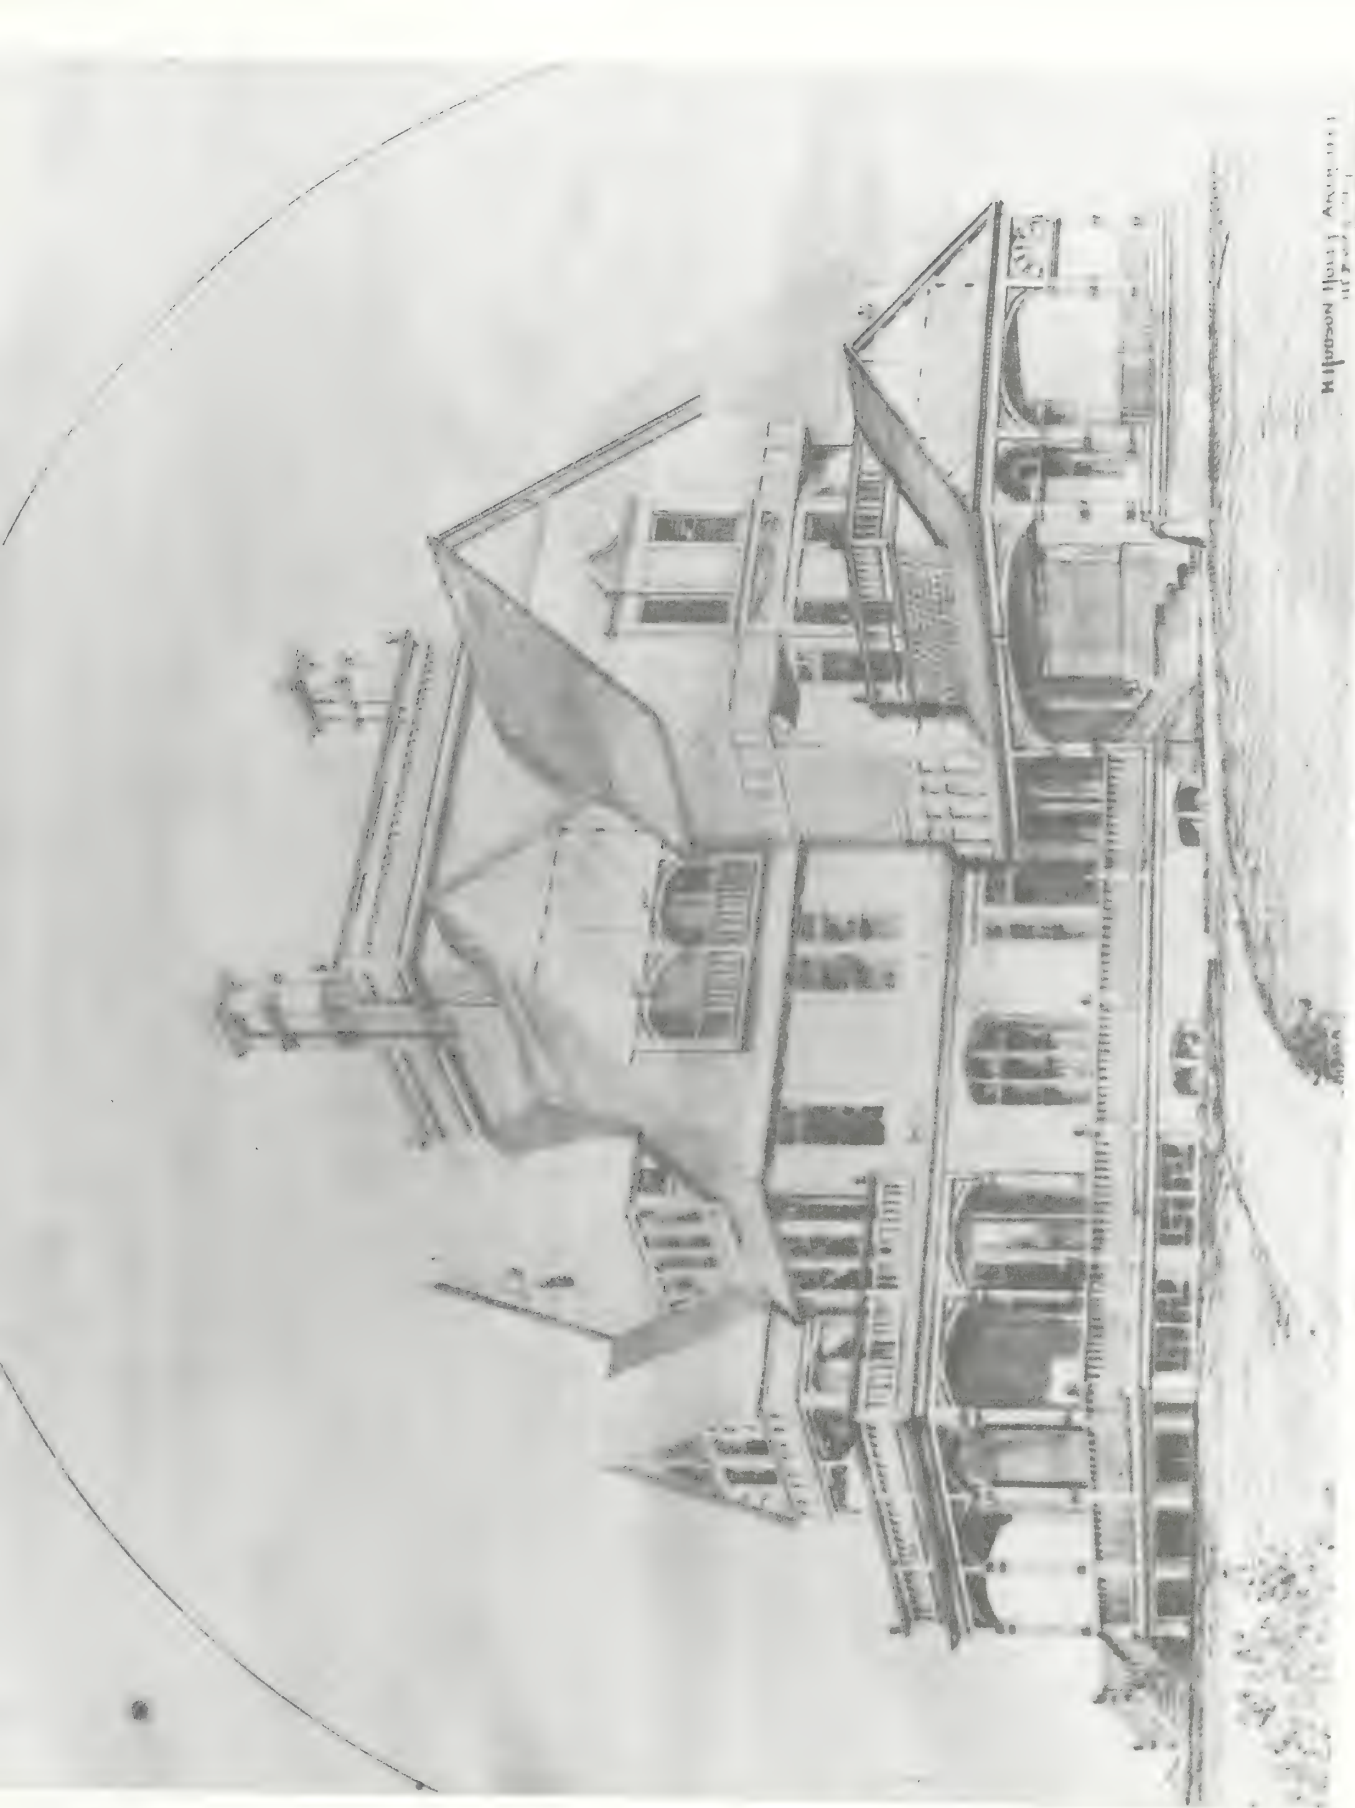
Figure 1. Early sketch of the Pedder house, January 30, 1880.

Despite this recommendation, Holly illustrated the chimneys in an early sketch of the house as being fairly plain in design (fig. 1).⁹⁹ The chimneys as actually constructed, however, were more in keeping with the style espoused in *Modern Dwellings*. The house was built with six chimneys of similar design. The tops of the chimneys were corbeled outward, and the two long sides of each stack were embellished with raised brickwork to look like pilasters. Each stack was capped with bluestone, and the top of every flue was fitted with a terra cotta pot.

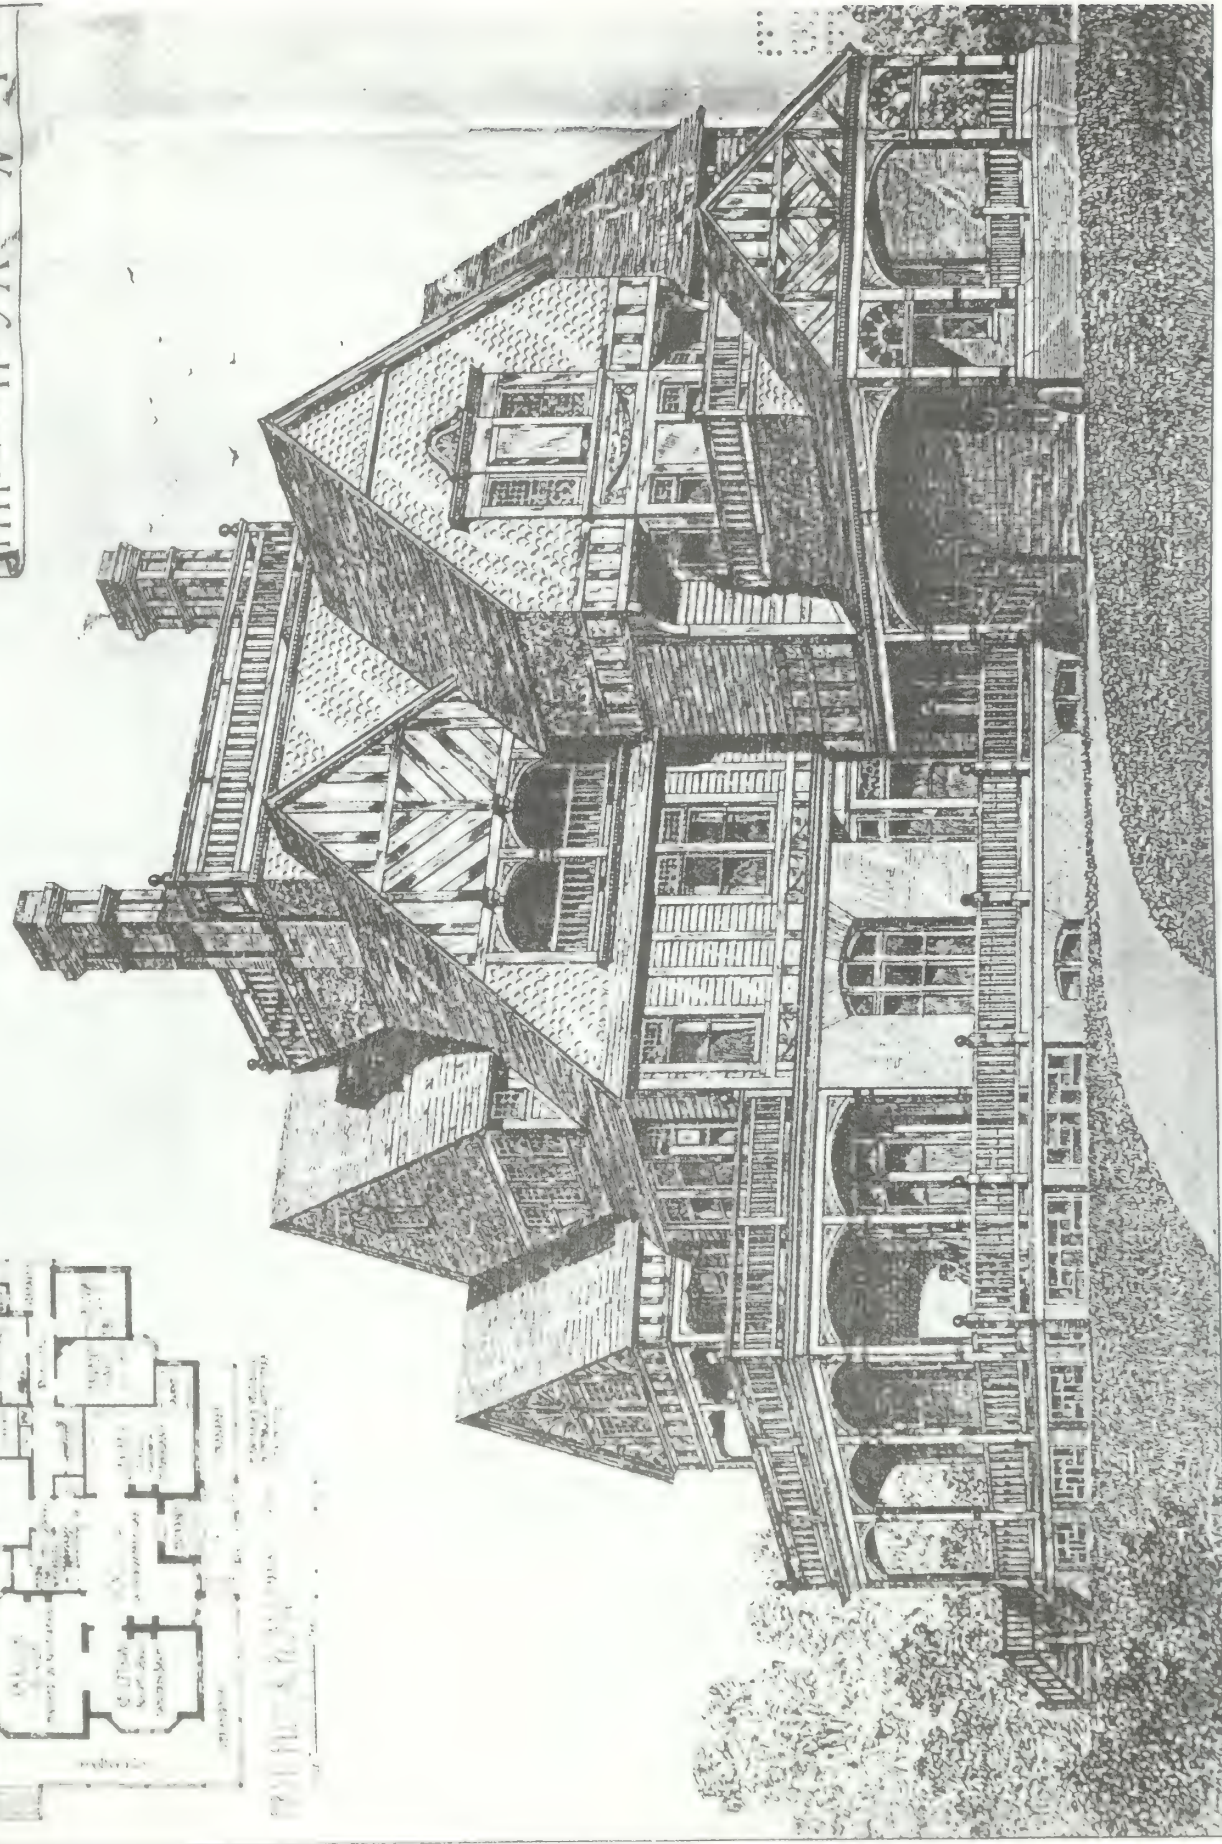
Residence of Mr. Henry C. Pedder.
 & Llewellyn Park, Orange, N. J.
 H. Hudson Holly, Architect, New York.

Figure 2. Exterior elevation drawing and first-floor plan, Aug. 27, 1881.

Two long, roofless porches stretch across the front of the house on either side of the front entrance. The porches are original features that were labeled "verandahs" on the first-floor plan published in *American Architect and Building News* in 1881. The porches are also documented by an elevation drawing that accompanied the floor plan (fig. 2), and by the earliest photograph of the house taken sometime before February 1884 (fig. 4). Each porch has a bluestone foundation with an end panel of wood lattice, a canvas floor covering, and a wood balustrade.

A smaller balustraded roof deck was here originally, atop the original south verandah (fig. 2). It was replaced by a larger balustraded roof deck above the Conservatory when the latter was built circa 1882 (fig. 4). Another roof deck was created just west of this deck when the Drawing Room was enlarged southward circa 1883-84. The new roof deck was incorporated into the existing Conservatory roof deck (fig. 5) to form the present-day south roof deck.

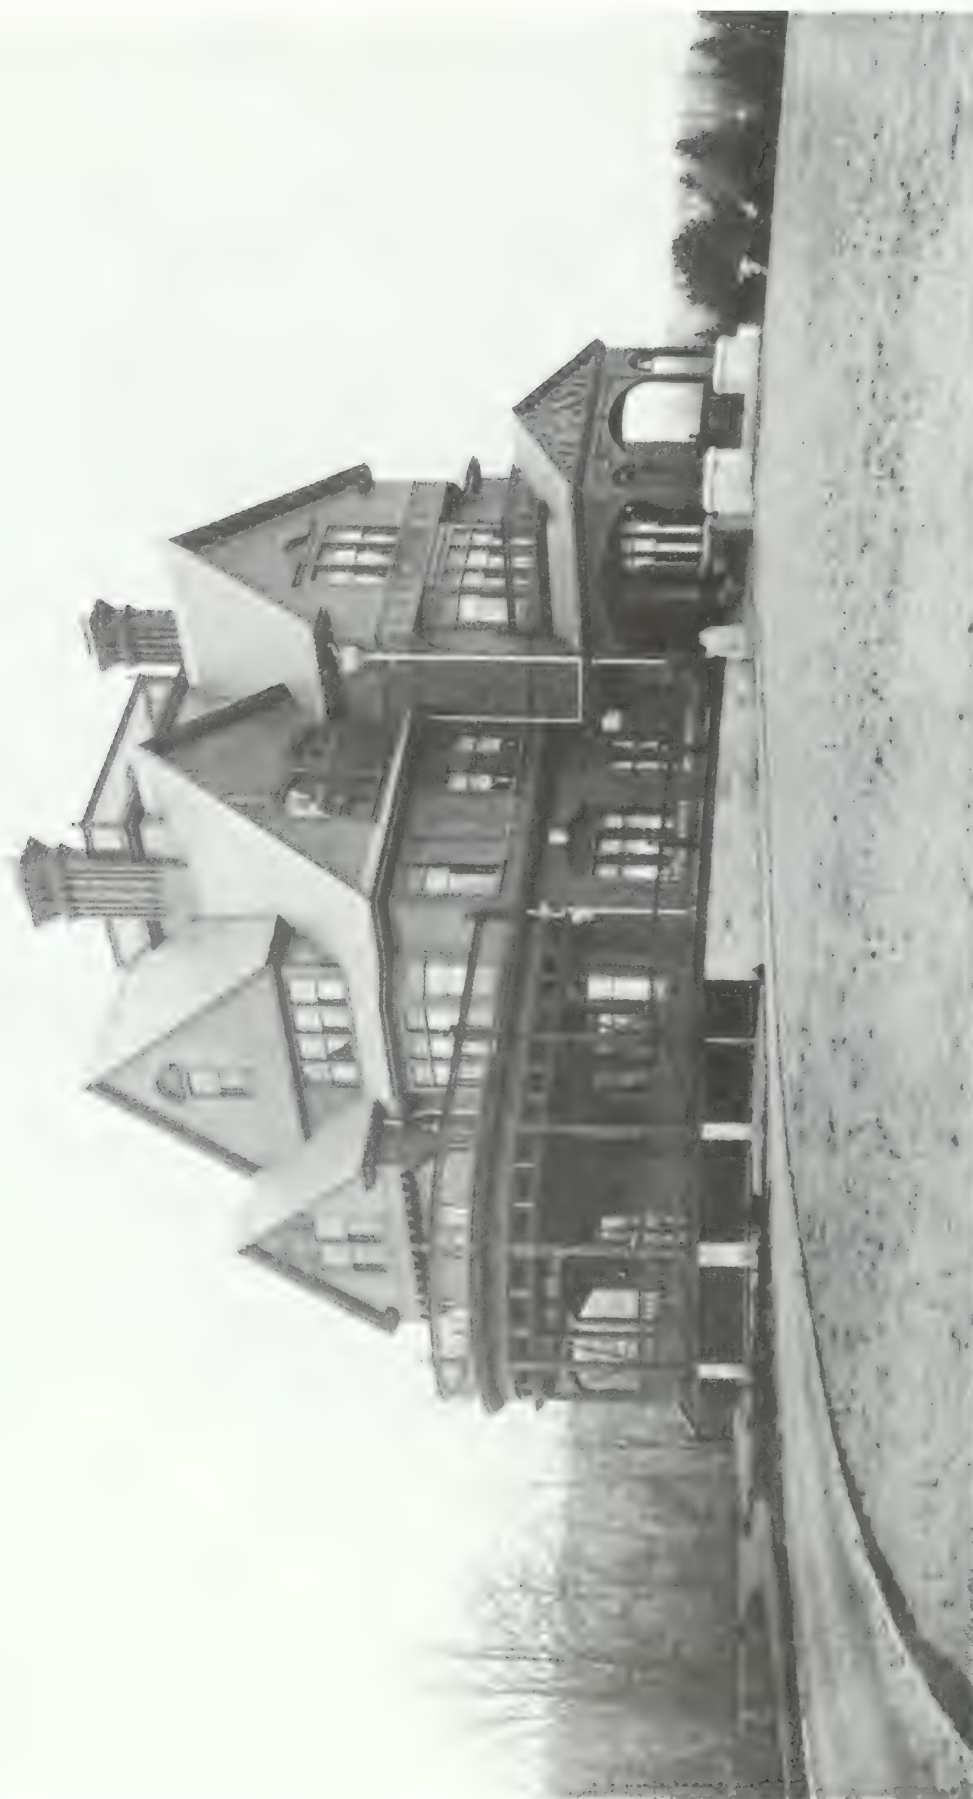
Figure 4. Earliest-known photograph of the Pedder house, circa 1882-83.

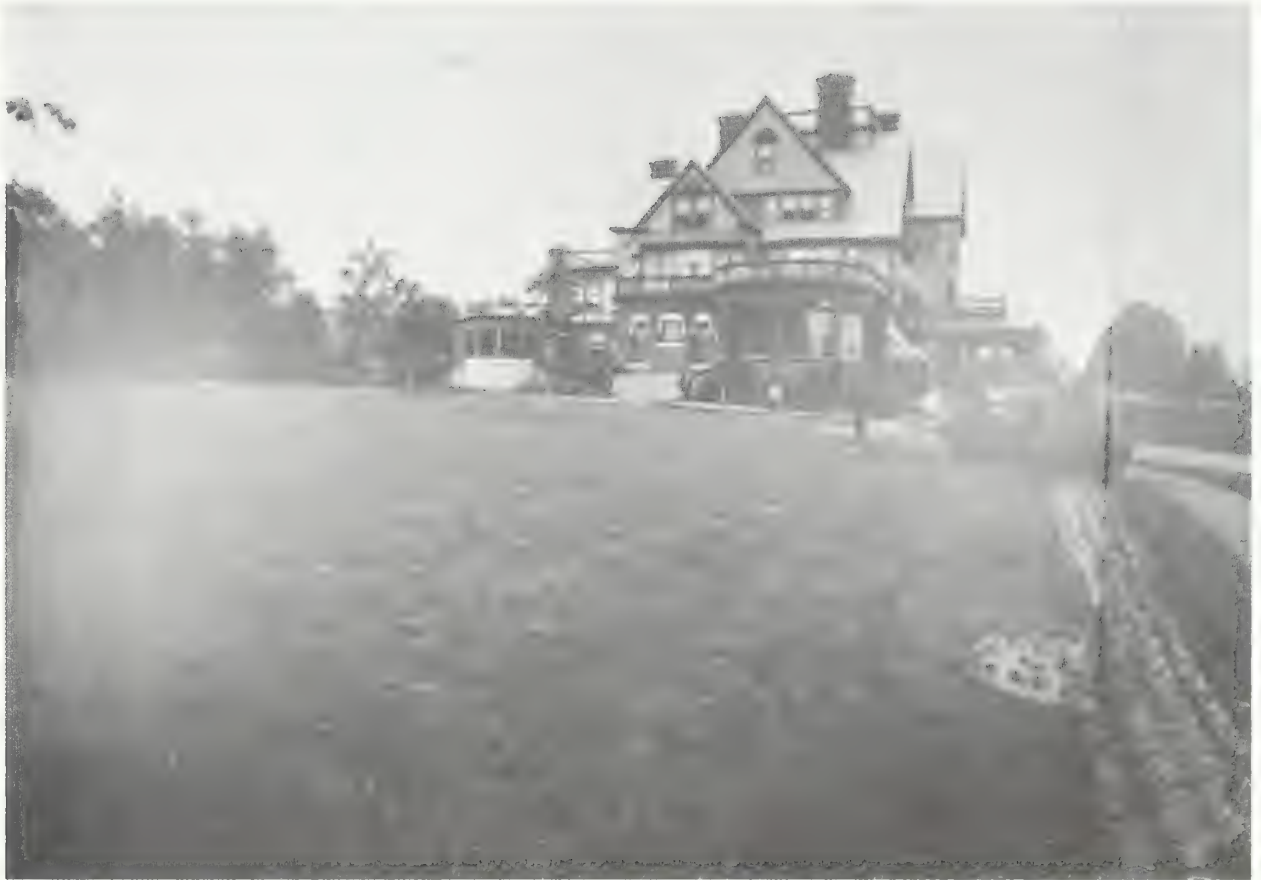
Figure 5. South elevation, circa 1884-90. Note the “billiard room” addition on the back (left) side.

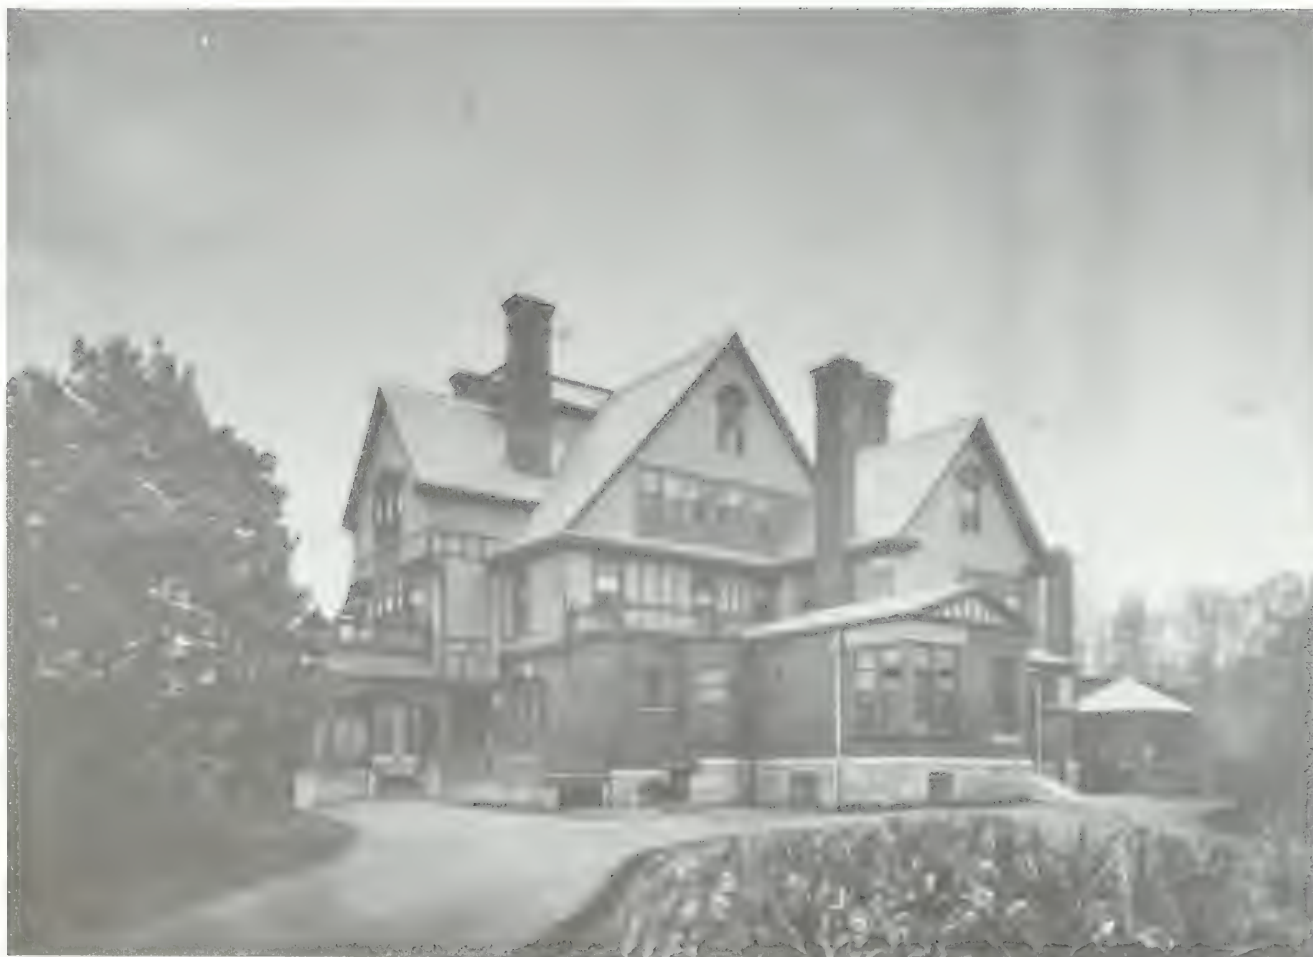
Figure 6. Northeast elevation, circa 1884-90.

The second-story roof deck off Mr. Theodore's Room (Room 206) was built in 1880-81. It functions as the roofs for the north alcove of the Library (Room 104) and the Service Dining Room (Room 105). The porch is documented by early photographs taken in the 1890's (figs. 6 and 10) as having had a wood balustrade with three posts.

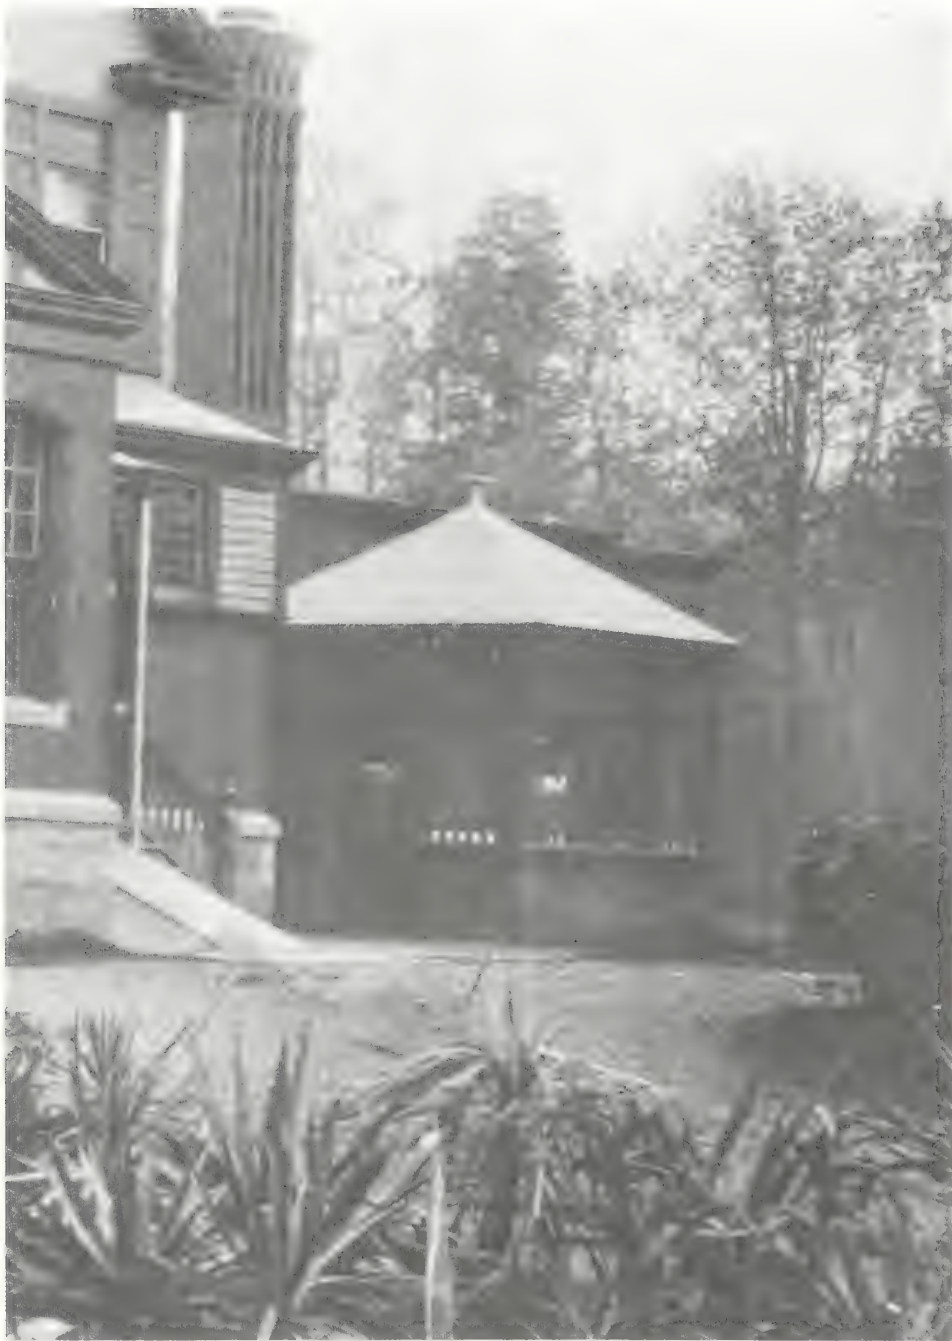
Figure 7. Detail of Figure 6, showing the “well house.”

7. Detail of figure 6, showing the "well house"	29

¹²⁰ It is believed that one of these buildings may have been the original well house that had been located on the north side of the house. The well house was moved in 1899, according to a bill from carpenter Adolph Vogel dated Dec. 15, 1899. Both buildings were wired for electricity by 1920, according to a memorandum dated Mar. 10, 1920, from the Edison Insurance Service Department.

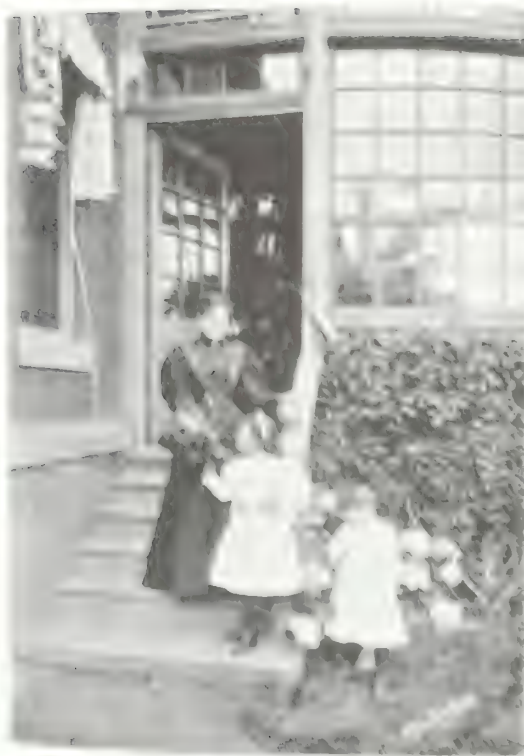
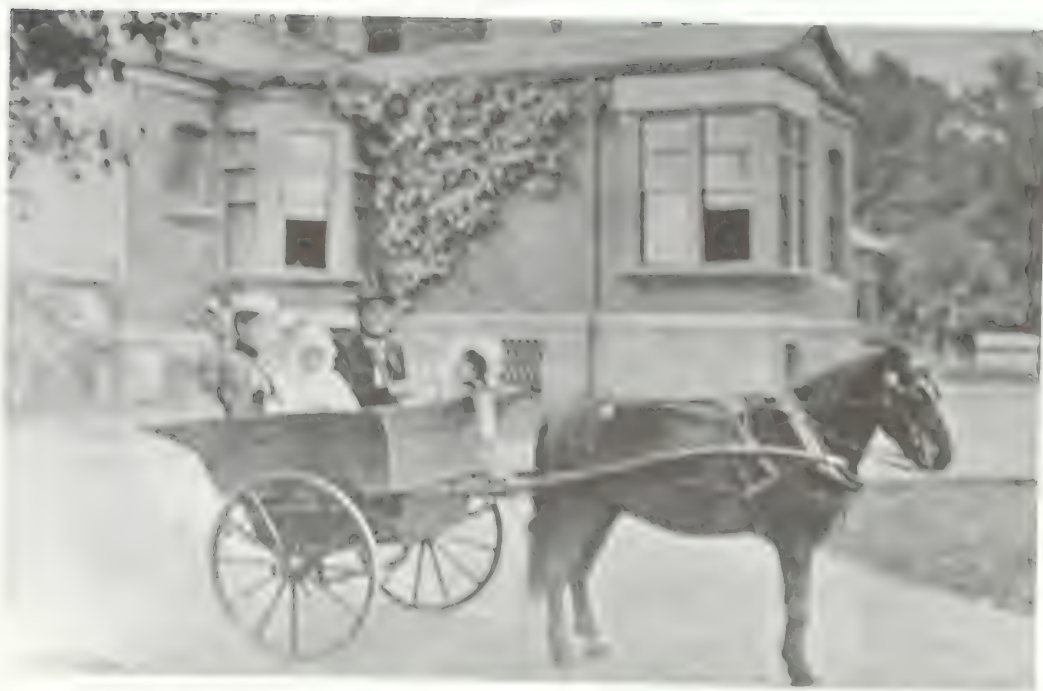
Figure 10. Close up views of the Conservatory (above) and the Service Wing (below), circa 1890-92

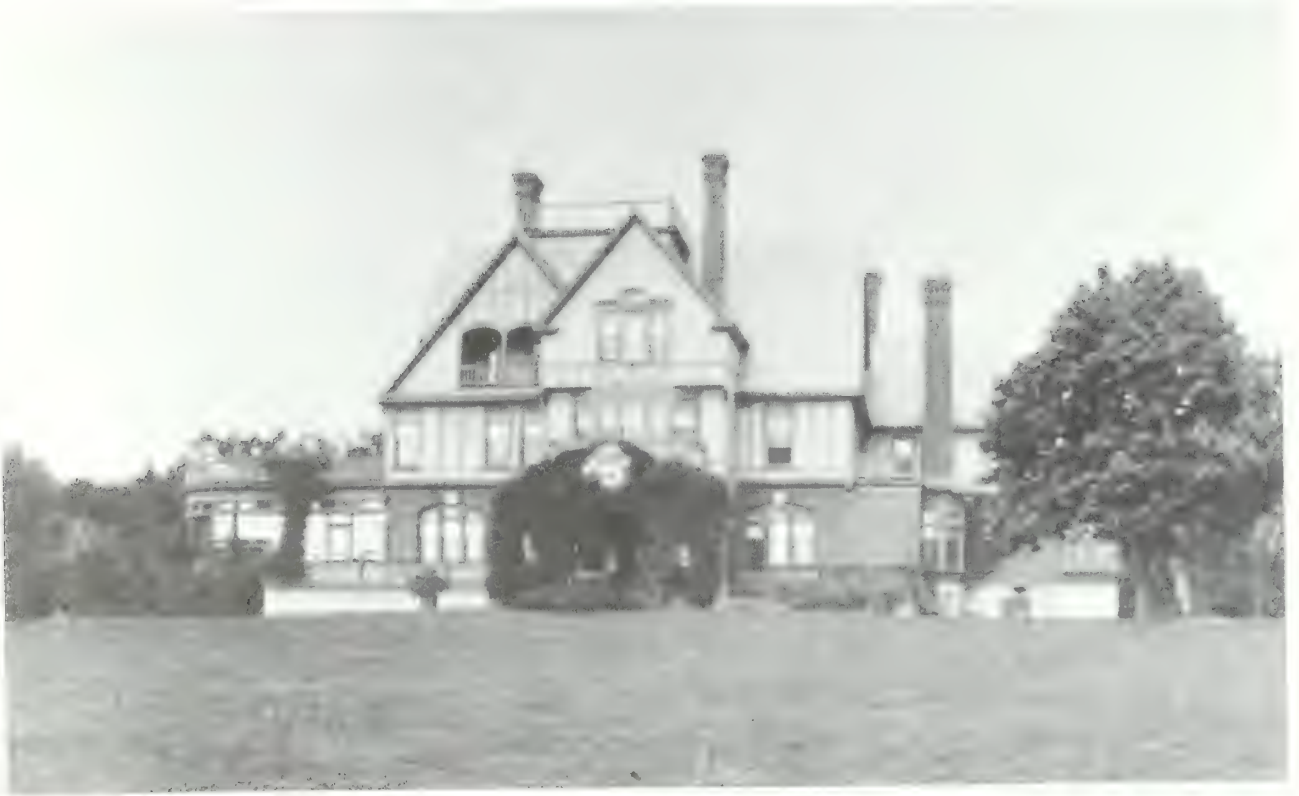
Figure 11. East elevation, circa 1891-97.

11. Photograph of the east elevation, circa 1891-97. The date 1891 is based on the presence of the hinged skylight covers at the Den that were installed in June of that year (see figure 12); the date 1897 is based on the dark trim color that was lightened by 1897. Edison NHS catalog #12.420/16, no negative 50

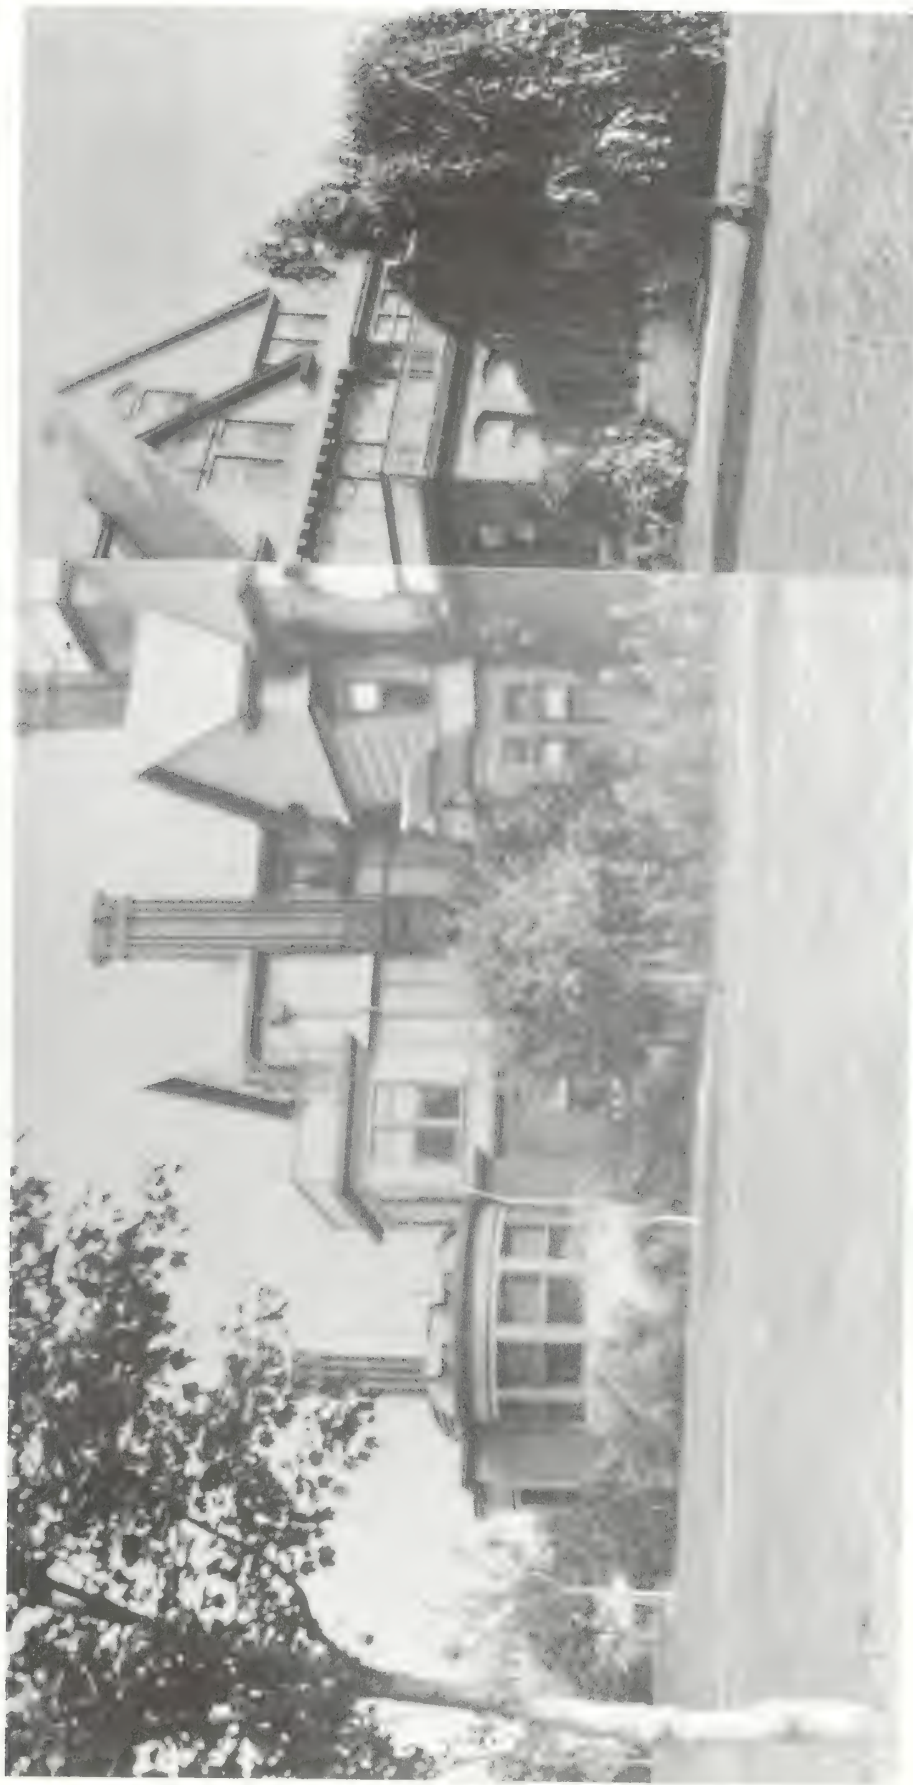
Figure 12. Southwest elevation, circa 1891-97.

12. Two photographs joined together to show the entire southwest elevation. Both views were taken at the same time as figure 11, circa 1891-97. Edison NHS catalog #12.420/29 (left side) 51

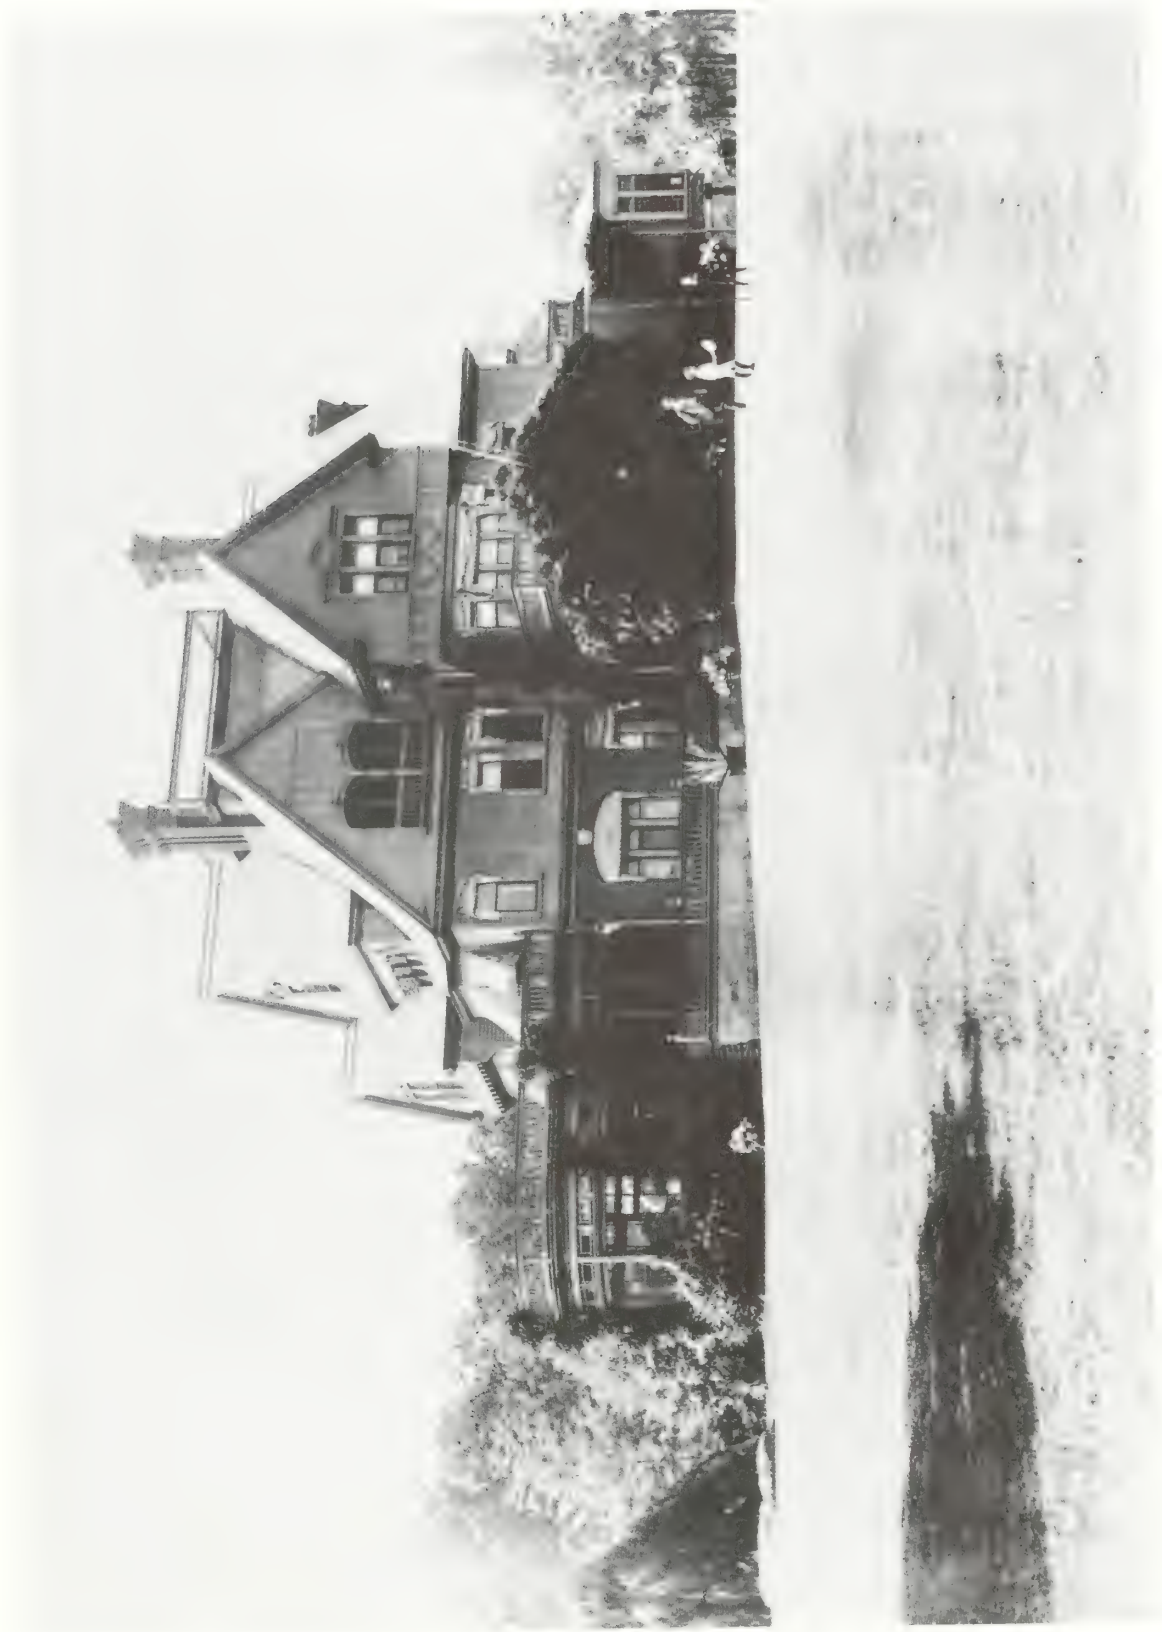
Figure 14. East elevation, circa 1897-1902.

that some of this work included making screens for the Conservatory, but this is not clearly stated. That the Conservatory may have been outfitted with screens about this time is suggested by an early photograph of the house taken sometime before 1903 that shows the screens in place (fig. 14). The Conservatory screens were divided into panels, with the large curved screens having six panels each, and the smaller flat screens having four panels each. These screens were removed during the cold months, when storm sashes were installed.

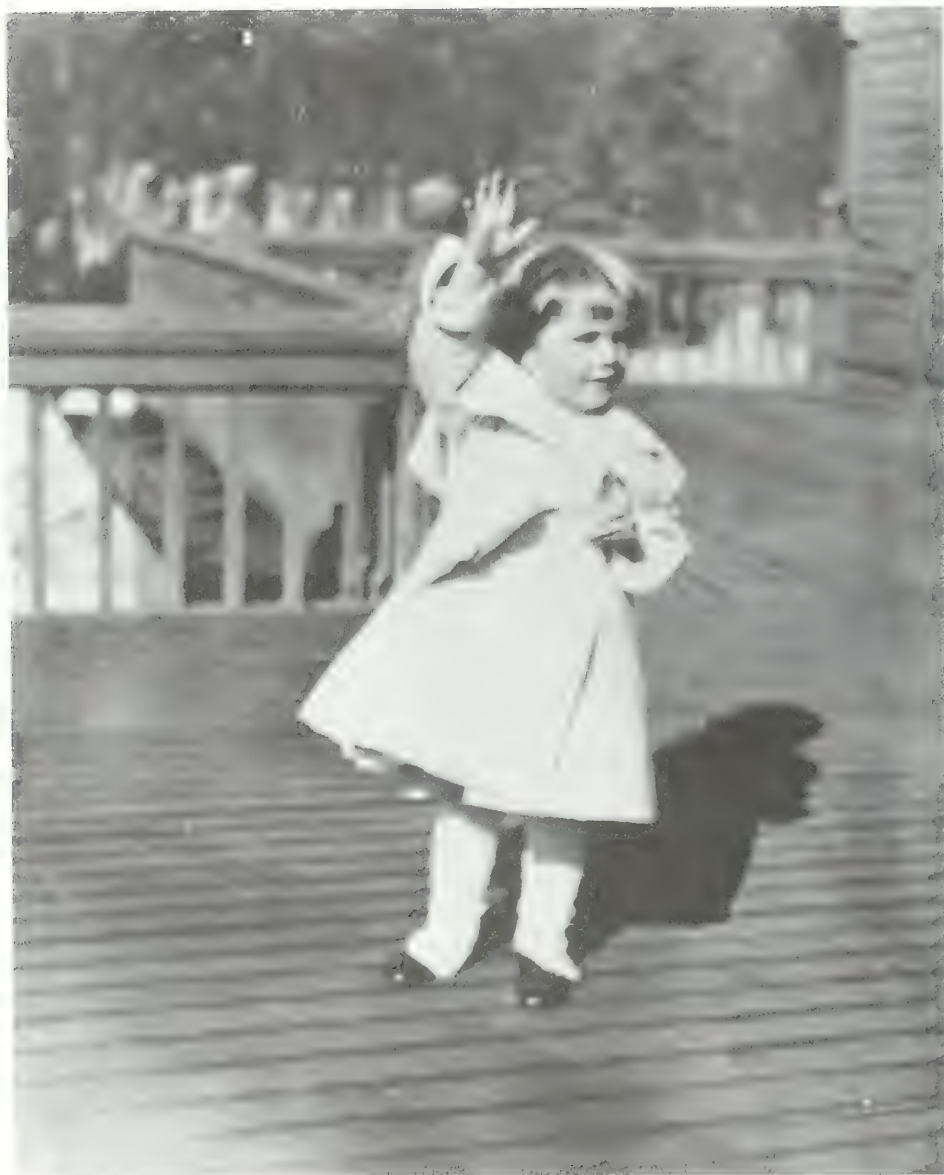
Figure 15. Theodore Edison on the south roof deck, above the Conservatory, circa 1902.

The second-story south roof deck was the one used most frequently by the Edison family. A large awning was installed over the Conservatory portion in May 1890.¹⁹ The flooring material was wood boards that were widely spaced for drainage, according to a photograph dated circa 1902 (fig. 15).²⁰ The Drawing Room portion of the deck, and part of the Conservatory portion, were screened in 1907 and enclosed with glass in 1935. For more information on the enclosed sun porch, see the discussion of Room 202.

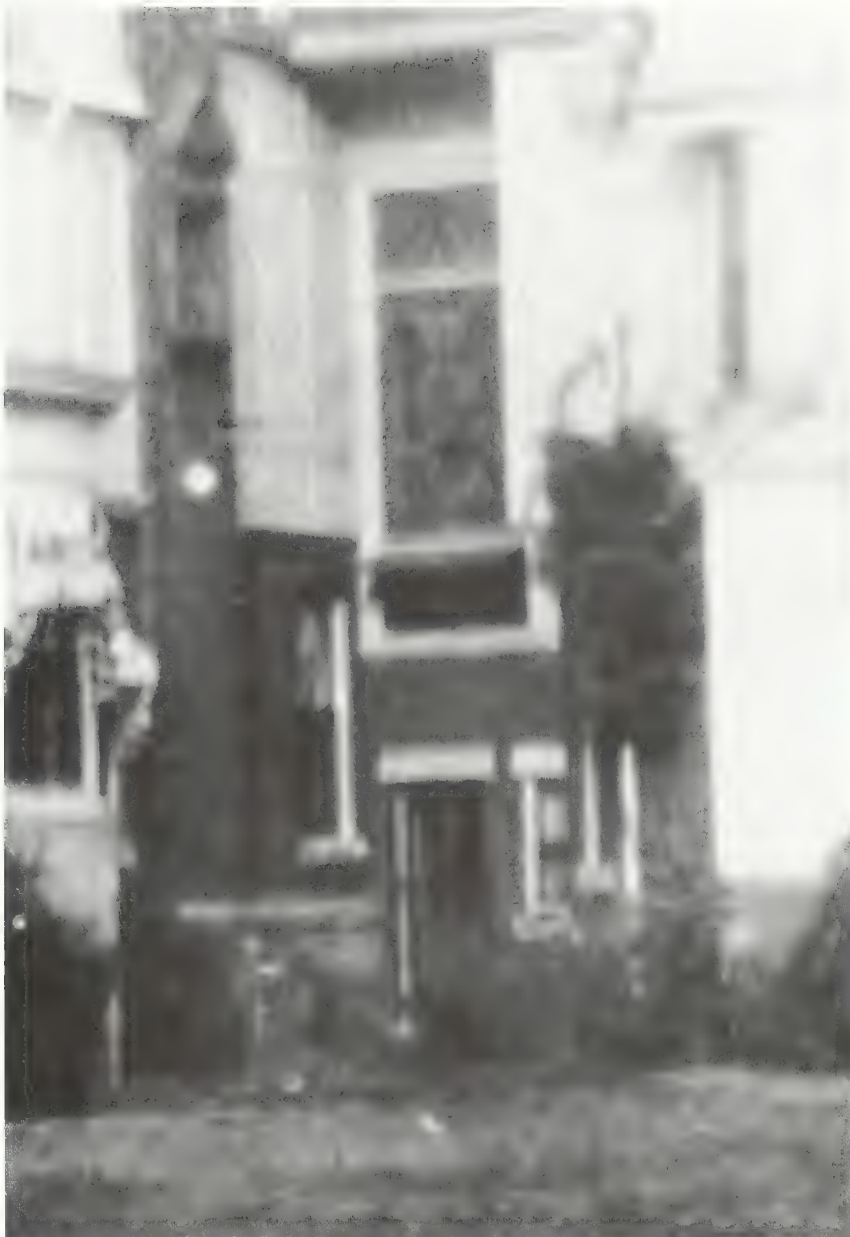
Figure 20. Detail of Figure 19, showing the original back doorway.

20.	Detail of figure 19, showing the original back doorway	59
21.	Photograph of the east elevation, 1914. Date attributed by the site. Edison NHS catalog #12.420/31, negative #2674	60

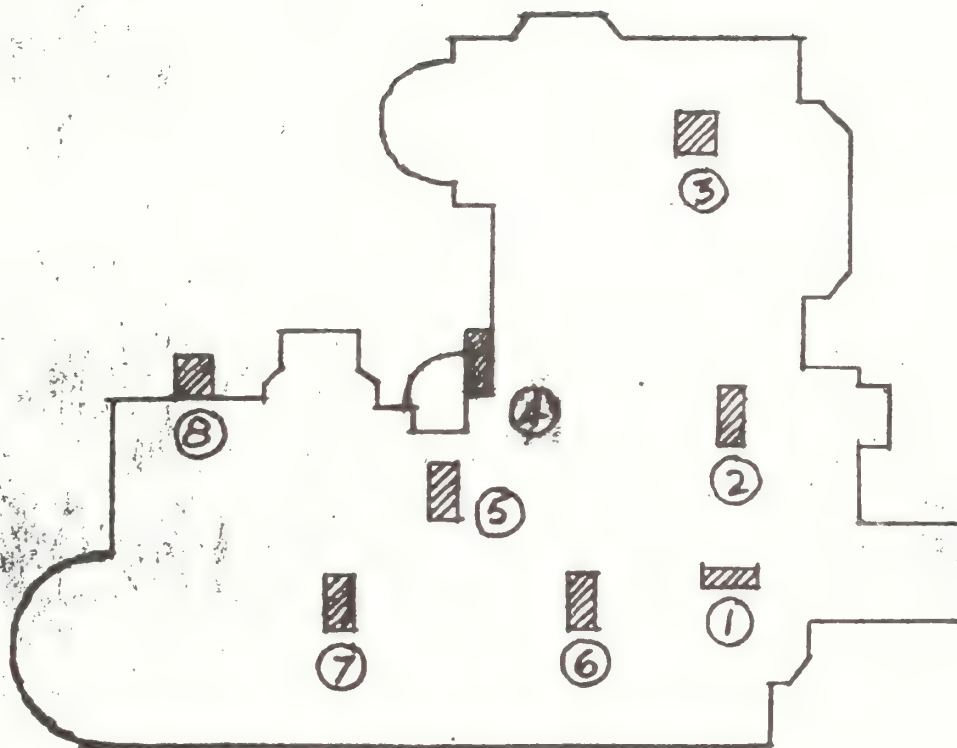
(FRONT OF BUILDING)

ROUGH PLAN OF GLENMONT CHIMNEYS

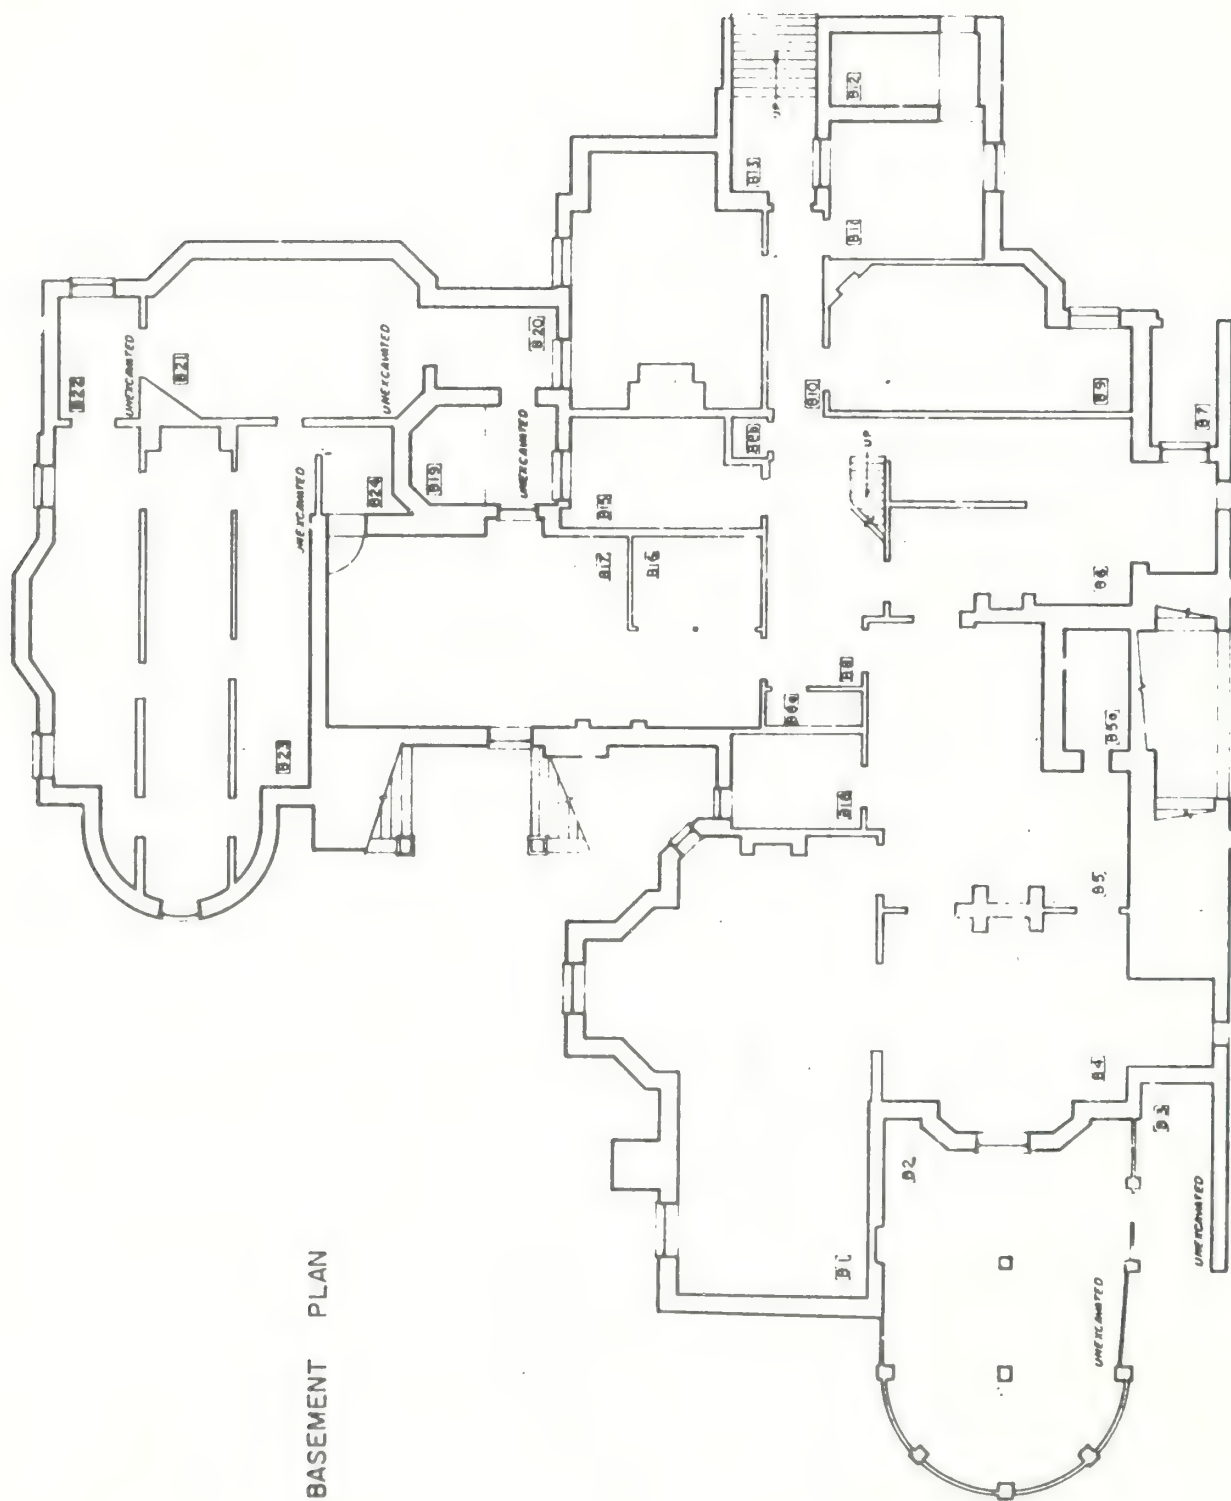
BASEMENT PLAN

403/
1/8" = 1'-0"
